# Preservation Estimate

**History Walks LLC**  
2636 Washington Street  
Omaha, NE 68107  
(816) 616-9162  
historywalksnebraska.com

**Name:** Emmanuel Evangelical Cemetery

**Name:** Anne Dehning

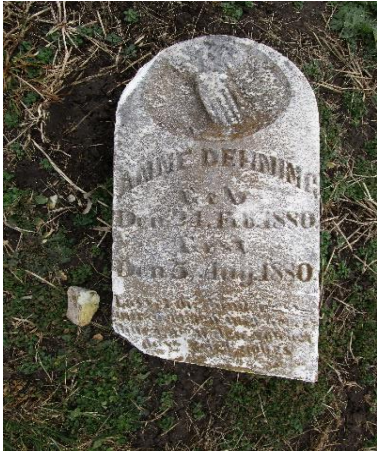
This monument has been broken off at the base. To repair it, we will clean the surface and use stone grade epoxy to reattach the monument to the base. Before doing so, we will unearth the base and set it properly so the monument will be level once reset. We will also clean this monument as it does have some lichen and dirt on the stone.

**Level:** Base needs unearthed and reset

**Piece Secure** 2 piece reattach

**Soiled (1 - 3)** 2
